Commissioning Report - Ground Heat Exchanger Testing and Observation
Minnesota Veterans Home – Bemidji, MN

October 3, 2023

Commissioning Report - Ground Heat Exchanger and Observations

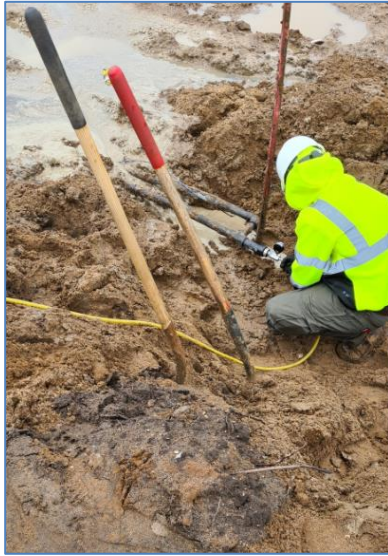
The contractor chose to use air to pressurize the loops, which is not the best or safest way to do the testing and it required a lot of air compressor time to apply enough pressure. They did not have sufficient numbers of pressure gauges available to put separate gauges on each loop, so they were permitted to check multiple loops at a time. At the end of the 24 hours, the pressure observed for detection of any leaks and the air was released. The temporary manifolds were removed and the loops were individually capped. A better method would have been to fill the pipes with water and use the compressor to pressurize only a small amount of air in each pipe.

Figure 14 – Pressurizing a completed loop

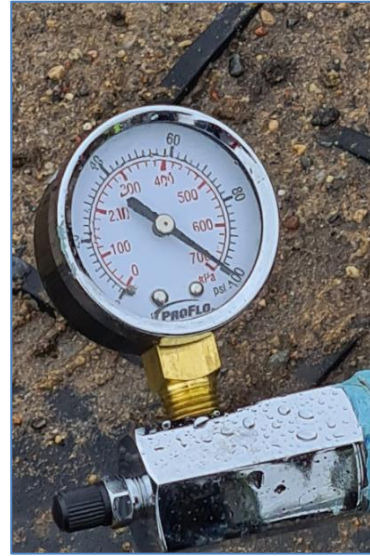
On completion of each borehole, the loop was pulled back through the borehole along with a tracer wire and third “tremie” pipe which was used for grouting. Each loop was pressurized to 100 PSI for 24 hours to test the integrity of the loop after being pulled into the 500-feet of borehole. In this installation, the testing assures that the tailpieces and U-Bend fusions were satisfactory, as well as whether the loop suffered any damage from rocks or other debris that may have been encountered in the pulling process. The pipes were joined in sets of multiple loops with a temporary “manifold” to allow one gauge to be used for pressure testing of more than one loop as each loop was completed. The loops were immediately capped and fittings were applied to protect the pipes from debris. The pipes were pressurized for a minimum of 24 hours at 100 PSI.

Figure 16 – 100PSI for 24 hours

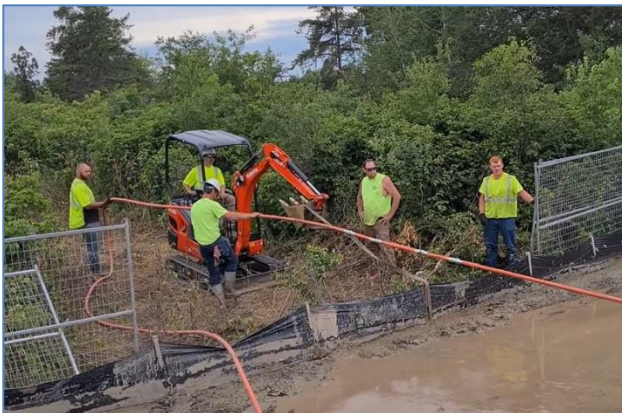
Figure 22 – When manpower was not enough to remove the tremie pipe

The tremie pipe was charged with grout and when the grout appeared at the surface of the open borehole at the far end, the tremie pipe was pulled at a steady pace while pumping to provide uniform filling of the borehole and loopfield pipes. The grouting process took roughly one hour per borehole. A hydraulic reel for the tremie pipe would have been an easier and more uniform pulling process.

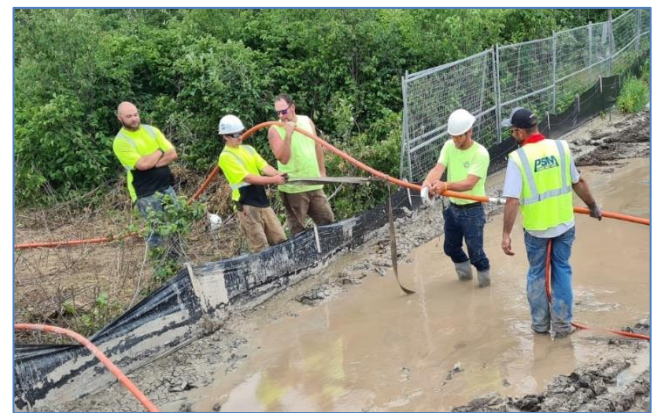
Figure 23 – Manpower was used to extract the tremie pipe as grout was pumped into the borehole

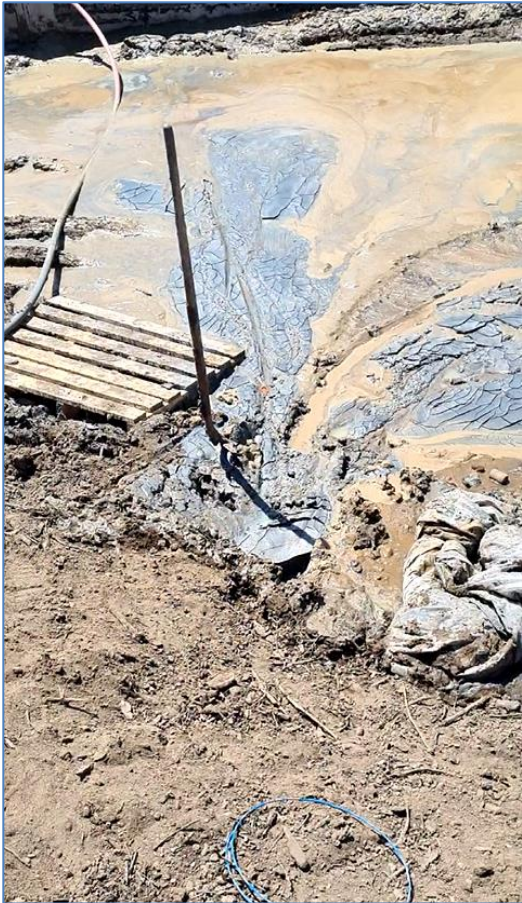
Figure 24 - Evidence of Graphite in Grout

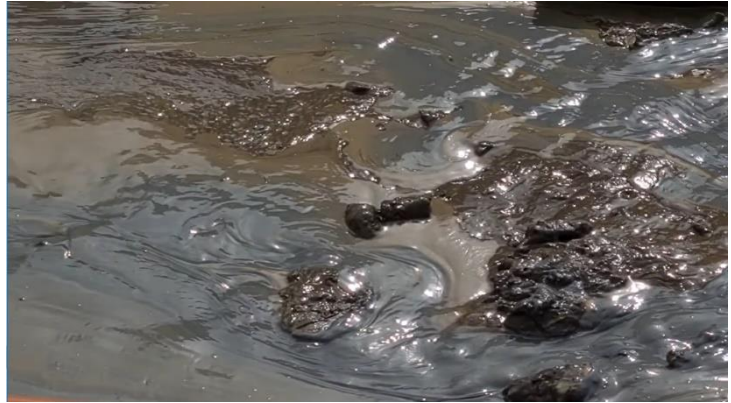
Figure 25 - Evidence of Graphite in Grout.

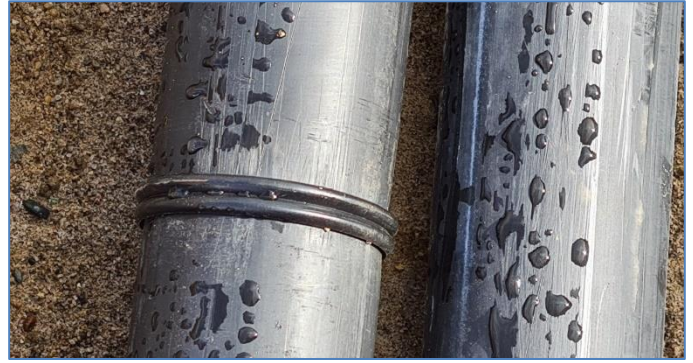
Figure 34 – Close-up of butt fusion of the 3" supply line

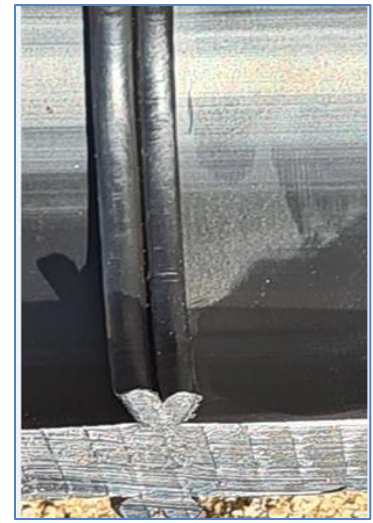
Figure 36 – Destructive Sample

- Fusions were observed for all types of couplings; saddle and butt connections. Destructive samples were taken of butt connections on couplings for 1.25" connections and for 3" butt connections. The samples showed excellent coverage. The fusion rolls were textbook quality.

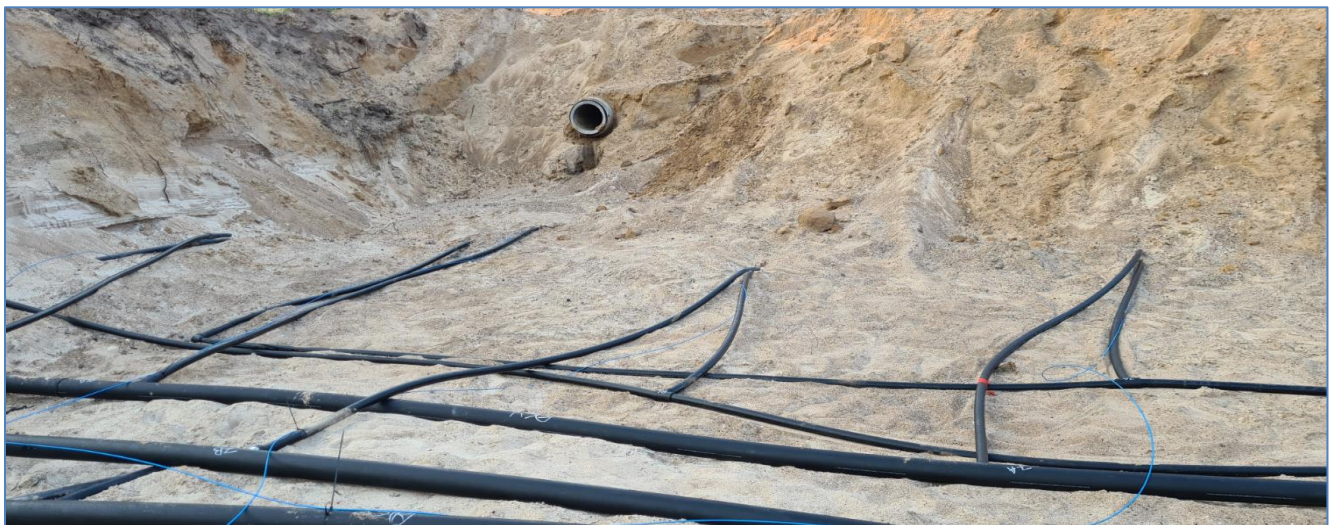
Figure 42 – Concrete culvert temporarily removed during the excavation of the tie-in area for the GHX.

the trench, there is a 16" concrete culvert running N-S which was temporarily removed as it ran above the area where the tie-ins were connected. I did not observe the replacement prior to leaving the site. The piping and connections and tracer wires are all very neatly configured and prepared.

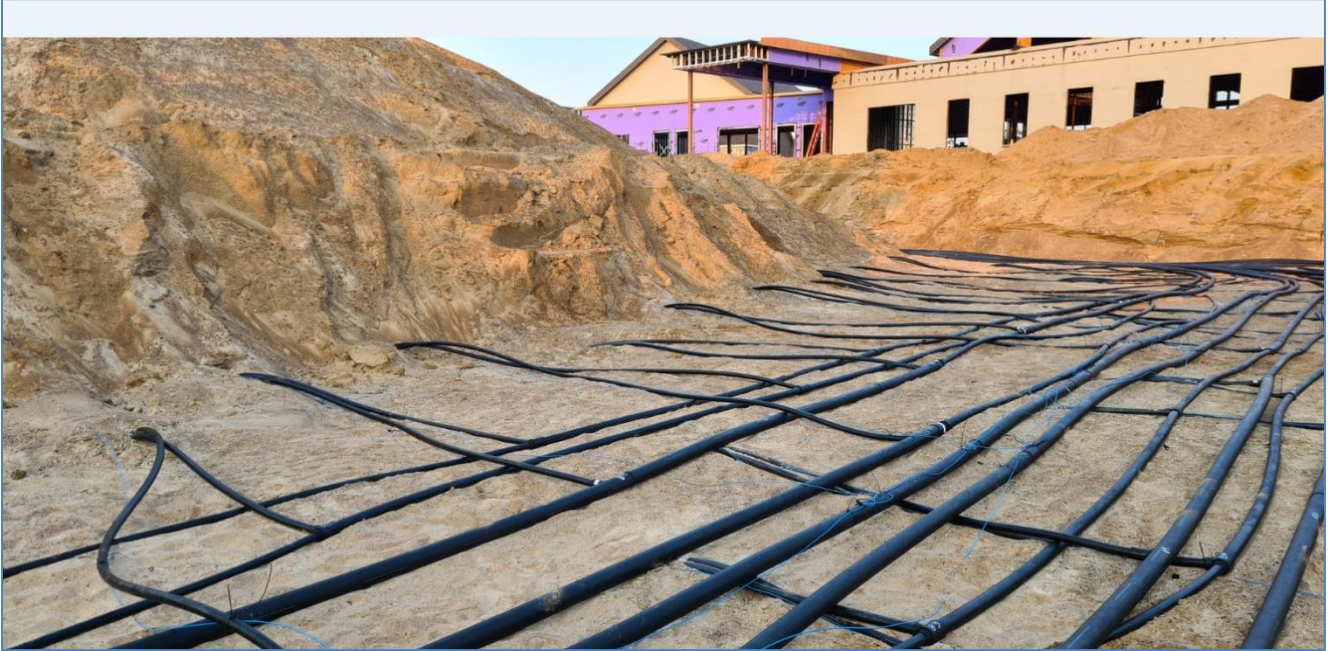
*Figure 43 – Loop Tie-ins and reducing headers connected to the circuit piping.
Pipes were hand bedded for separation prior the system being covered.
Tracer wires showing and connected back to each circuit pipe into the mechanical room.*

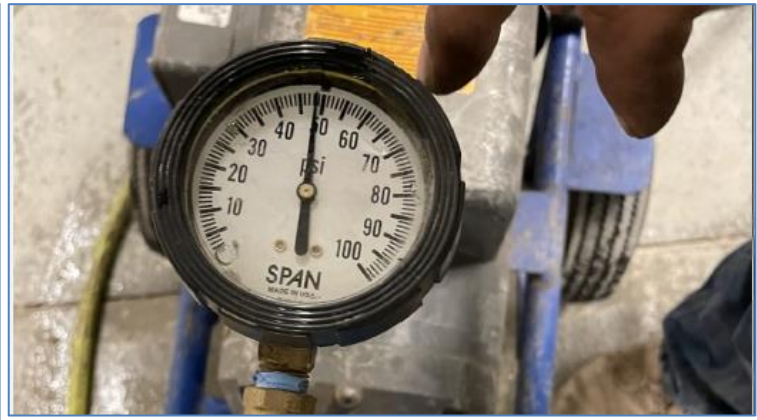
Figure 57 – Purging Pressure from Pump. No documentation provided for GPM, although a meter is present in Photos

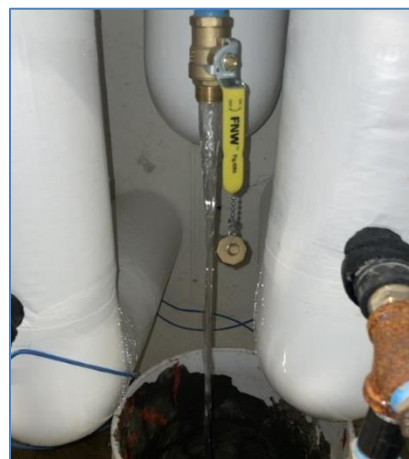
Figure 63 – PSM Photo of “Glycol Displacing Water”

The Glycol Solution which was installed was “Field-Mixed” as opposed to the expected factory 25% premix solution. The field mix was created by means of manually mixing the clear concentrate and local water which was run through a set of filter tanks. The “field mix” was reported to be a ~30% solution by volume and there is no information regarding the mixing process (mechanical paddle mix or simple introduction of glycol to water using the small electric transfer pump). After the field mixed solution was created, the 250-gallon tote was pumped into the system using the small electric transfer pump.

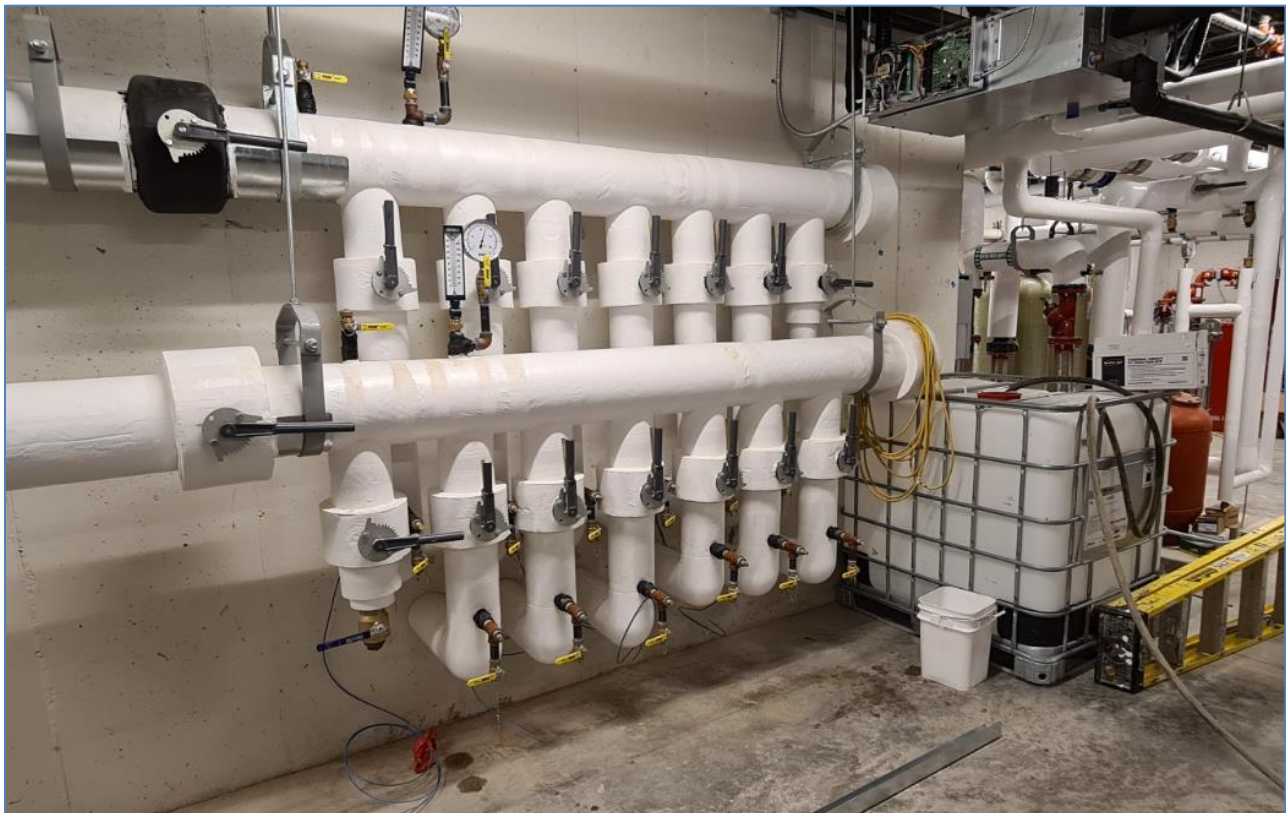
Figure 68 – Mechanical area with GHX Circuits and Final Valve Positions. The Tote to the right is for the 55-gallon supply of Glycol Solution to be left for future use as needed. It is the 30% field mix that is used in the GHX.

Based on the photos and notes received from PSM, the installation of the glycol into the system does not meet the glycol premix specification requirements.

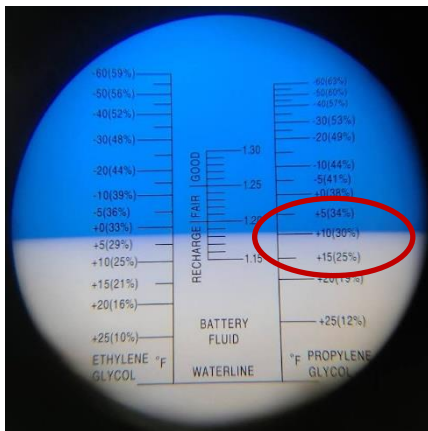
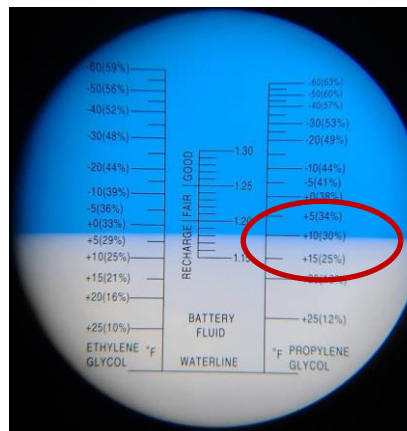
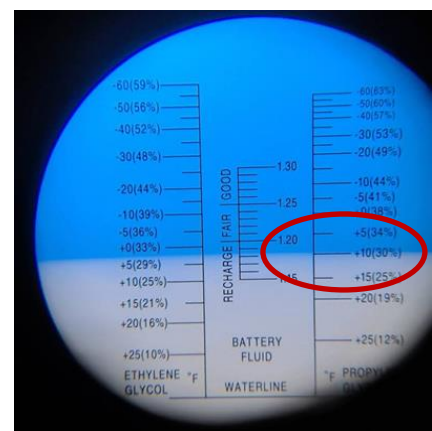
Figure 69 – Glycol concentration Sample 1 Figure 70 - Glycol concentration Sample 2 Figure 71 - Glycol concentration Sample 3

There were (3) samples taken on 8/31/23 from the taps on the supply and return lines to test the concentration of the fluid. Note that the system was active and pumps were running during the time that the fluid was extracted. Samples were taken about 5 minutes apart. All of the samples were evaluated with a glycol refractometer on return to the office and found to be ~30% concentration.

Analysis of the solution by Kurita America confirmed the solution percentage to be ~27% glycol and the additional chemical analysis of the solution and make-up water is provided in the report appendix. A comparative report for a factory grade premix solution was not available.
