Thermal Dynamics, Inc.
Maple Plain, MN 55359

Commissioning Report - Ground Heat Exchanger Testing and Observation
Minnesota Veterans Home – Montevideo, MN

June 28, 2023

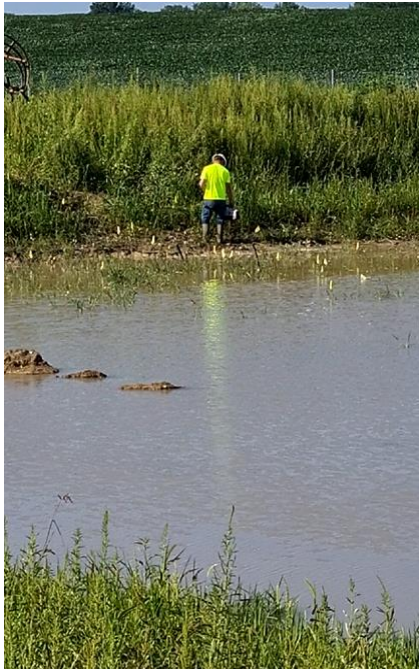
Locating did not encounter any issues with other utilities in the area. A drilling log was retrieved which shows the depths and locations of each borehole. The pond presented difficulties due to deep mud and the need to travel through areas of standing water. A pump was needed to drain water that accumulated. Better planning might have timed the excavation after the loops were installed.

Figure 14 - Locating Challenges with Pond

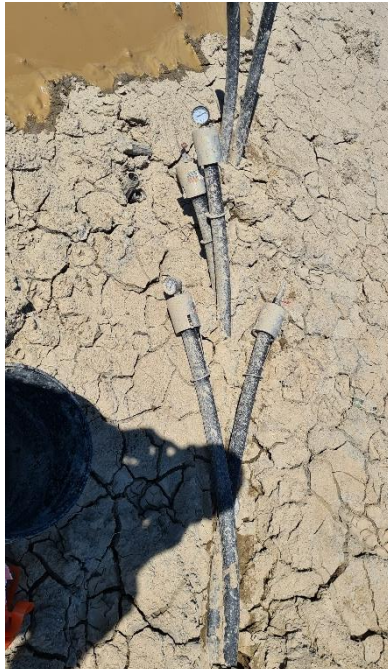
Figure 15 - A Row of Loops Under Pressure Test for 24 Hrs after Grouting

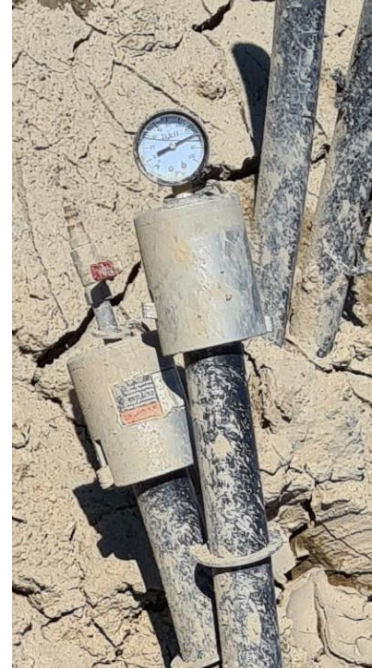
Figure 16 - Loops Pressure Tested to 80PSI

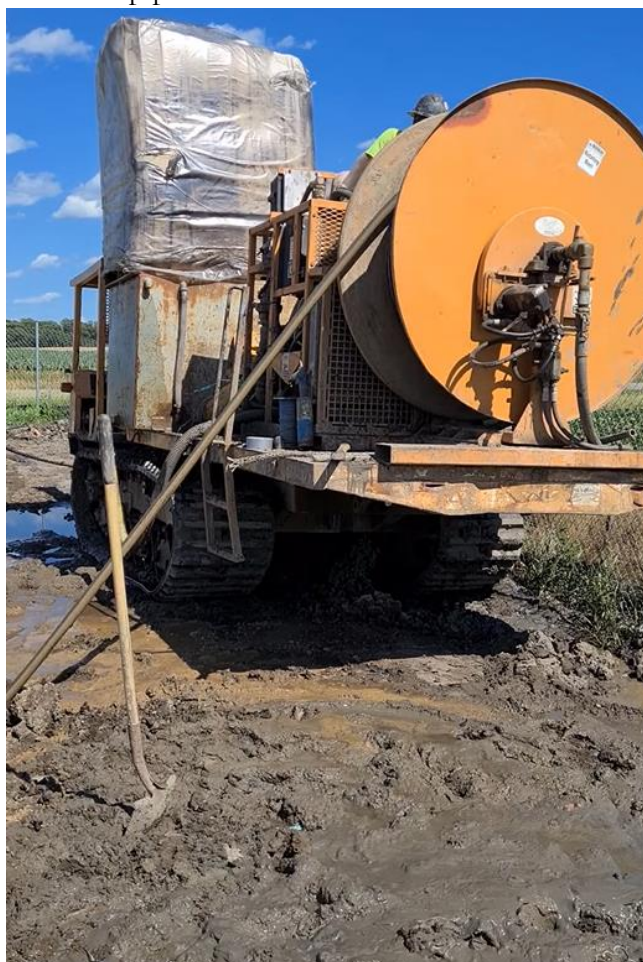
Figure 19 - Grouting Machine and Operator Extracting Tremie Pipe Using a Hydraulic Reel. Note Proximity to Fence.

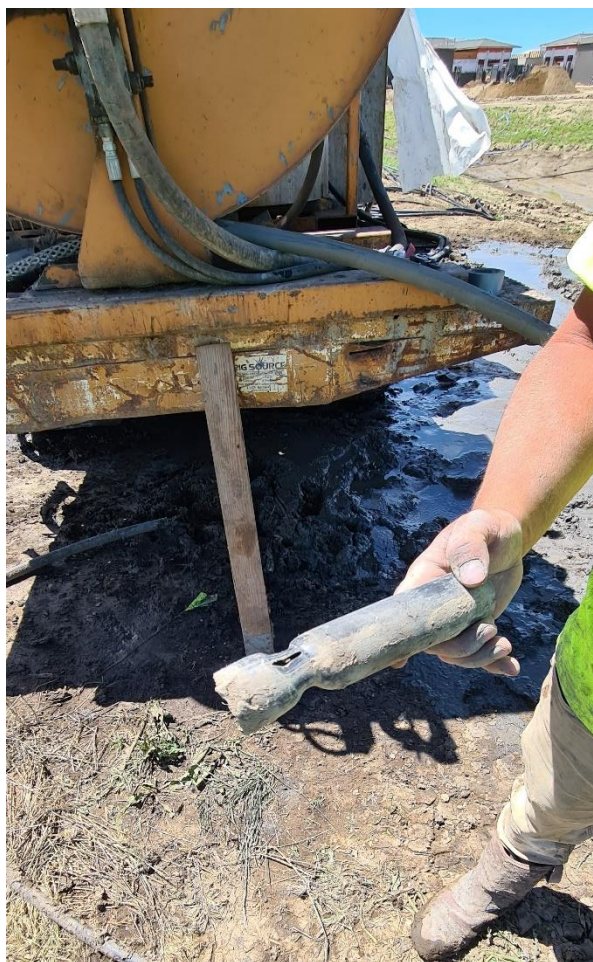
There were a couple instances in the grouting process where the tremie line could not be successfully pulled back from the borehole due to the sharp angle of drilling which was required due to inadequate space on the jobsite for such long bores. In a couple instances, the Engineer made the decision to require the boreholes to be redrilled and grouted in a new location just above the abandoned boreholes where the pipes were cut off and abandoned.

Figure 20 - Tremie Pipe Separation. Borehole Angle and Resistance Prevent Successful Grouting of Early Borehole

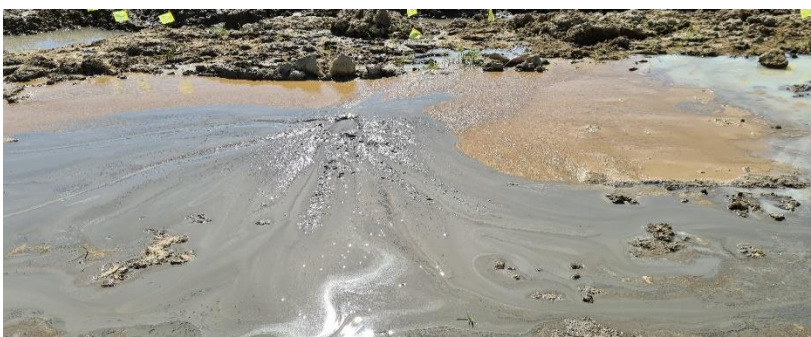
Figure 23 - Evidence of Graphite as Grout is Pumped Into Borehole from Tremie Pipe

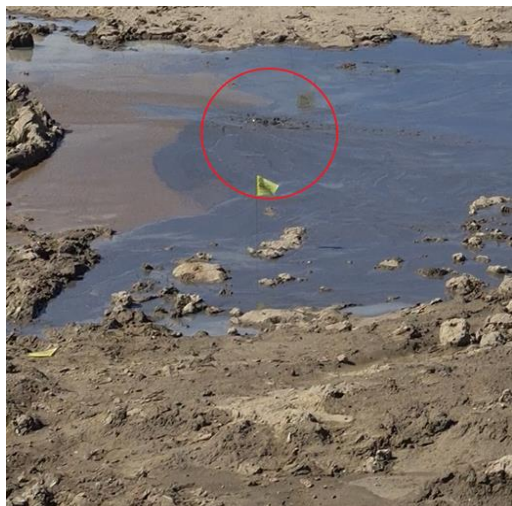
There were some issues with the grouting process due to the pond being excavated prior to the loopfield being installed. In addition to the locating job being made difficult, the bottom of the pond was very close to the upper layer of loops at ~16 ft below grade. When boring and grouting is being done, there are tremendous hydraulic pressures from the drilling fluid and from the grout pump and fluids will find the path of least resistance. On multiple occasions, the fluids broke through the bottom of the pond and made grouting coverage of the borehole difficult. There were multiple “break-throughs” of the fluid which caused wasted grout. Grout samples were taken on three different days and tested to assure TC.

Figure 24 - Hydraulic Pressure Breakthrough on Pond Bottom. Note Evidence of Graphite in Grout.

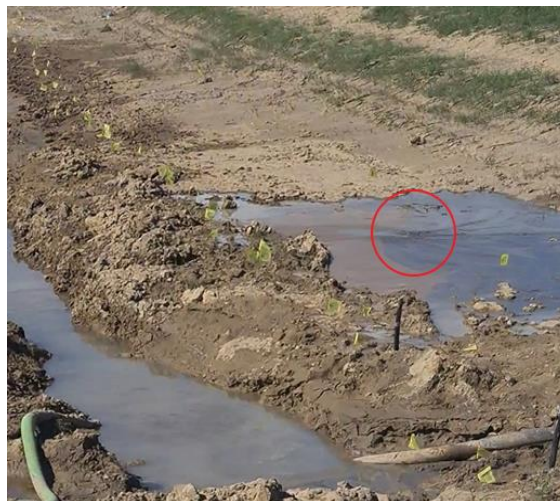
Figure 25 - Hydraulic Pressure Breakthrough on Pond Bottom. Note Evidence of Graphite in Grout.

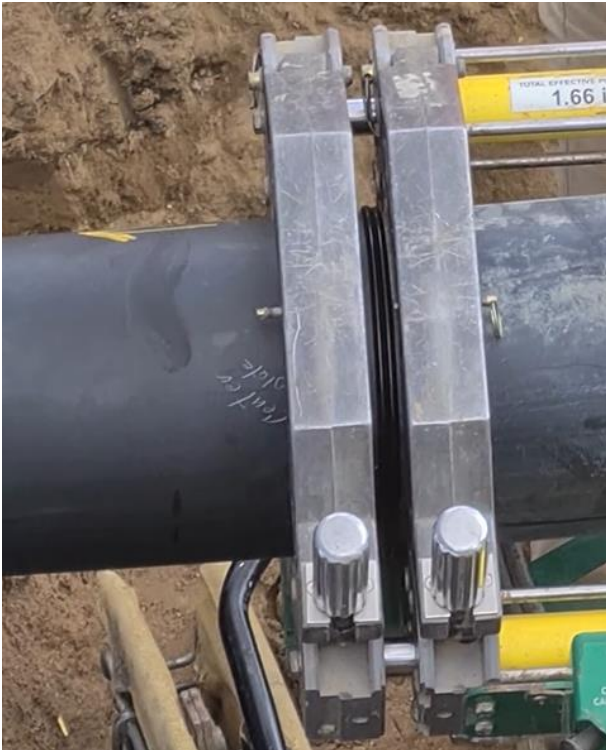
The 8" Supply/Return fusions were observed and inspected for the roll and uniformity.

Figure 32 – Supply/Return Fusion of 8" HDPE Pipe

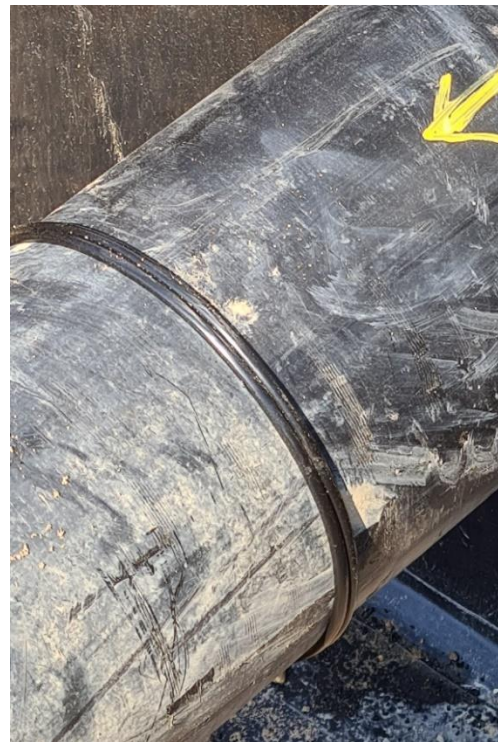
Figure 33 – Supply/Return Fusion of 8" HDPE Pipe

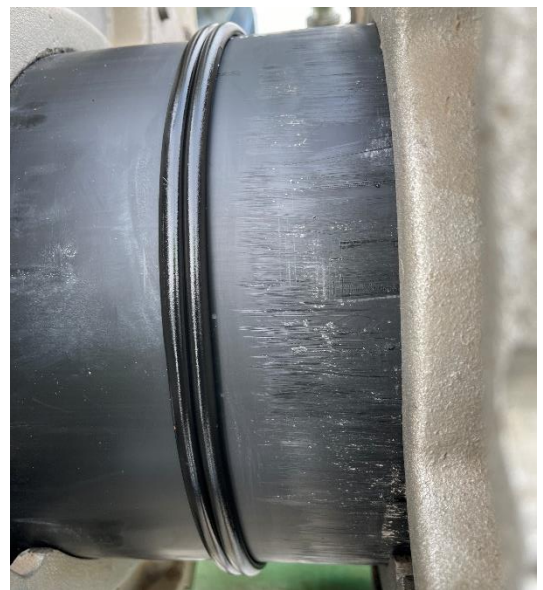
Figure 37 – Completed 8" Fusion Joint

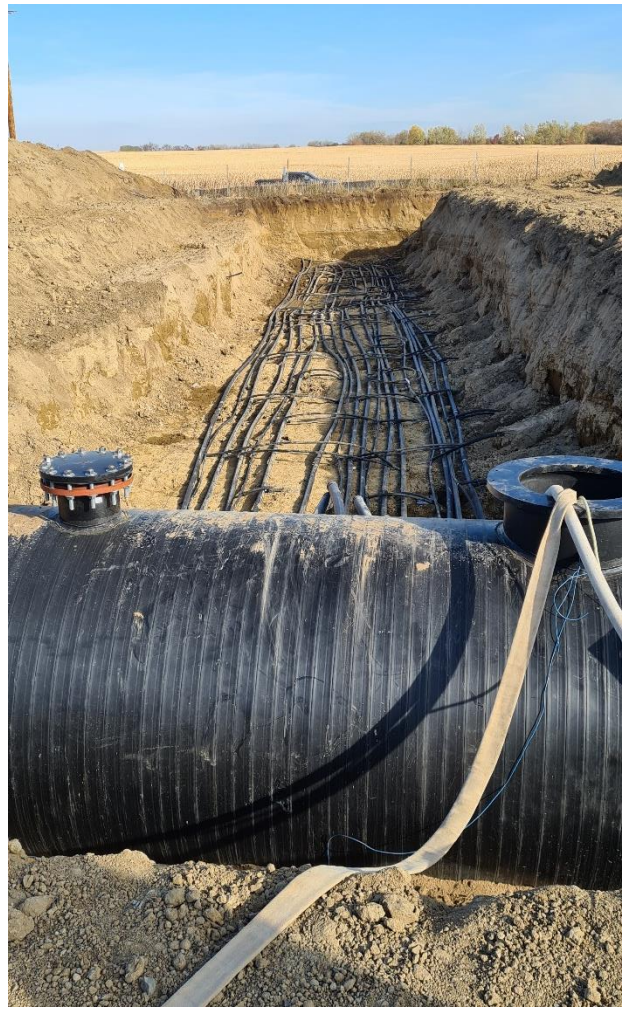
*Figure 46 – Trench with Circuit Tie-Ins connected to Loops in 12-ft Deep Excavated Trench.
The Trench Measures Roughly 90 ft x 30 ft x 12 ft*

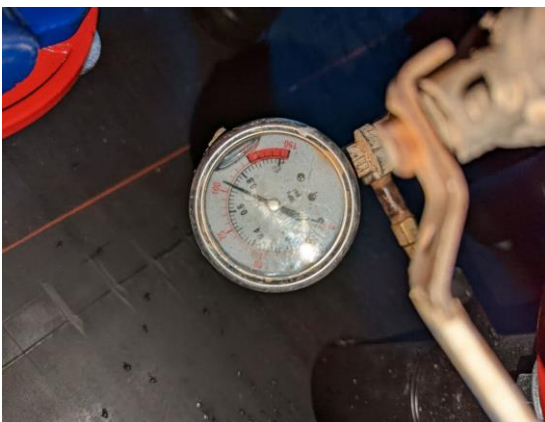
Figure 47 – Pressurized Circuit Under 24 Hour Test and Isolated in the Geothermal Vault.

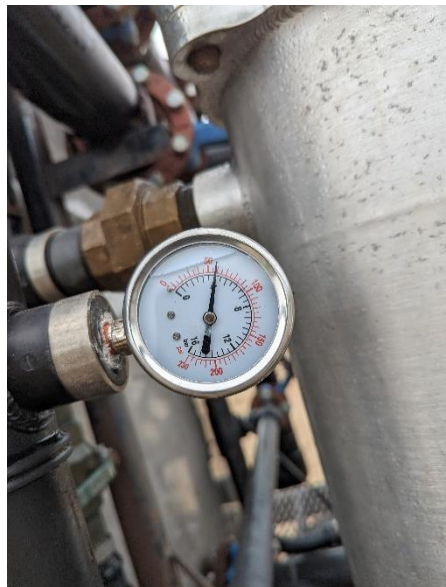
The 8" HDPE lines from the Geothermal Vault to the mechanical room were flushed separately. There was an issue with the plumbing in the mechanical room as only a 3" crossover was provided between the 8" lines. The engineer requested that the 3" pipes be replaced by 6" but the work was not completed, so it was necessary to flush the 8" lines with a 3" restriction. All of the work was done from the Geothermal Vault as there were no purge connections available inside the mechanical room. The 8" lines were purged for one hour and a flow of 250 GPM was achieved. After completion of the flushing. The water in the 8" pipes was filtered through 5-micron filtration bags for 30 minutes each direction. The additional restriction of the filter limited the flow to ~205 GPM. On completion, the valves to the building and all circuits were opened and the system was pressurized to 100 PSI and allowed to stand for 24 hours. The system held full pressure for the 24-hour period.

Figure 55 – Purging Pressure Through 8" Lines to Mechanical Room

- Purging and flushing of the 8" lines to the mechanical room was not optimal. The cross connection provided was not adequate to meet the requirements needed for velocity in an 8" line. A 3" cross connection is not sufficient. The engineer ordered a correction in the mechanical room to supply a minimum 6" cross connection but the work was not done. The engineer approved using the best effort with the limitation of the 3" line. While 250GPM was achieved, the lateral flow rate was not sufficient for an 8" line. The commissioning visit report was shared and recommended additional filtering efforts prior to full operation with the pumps.

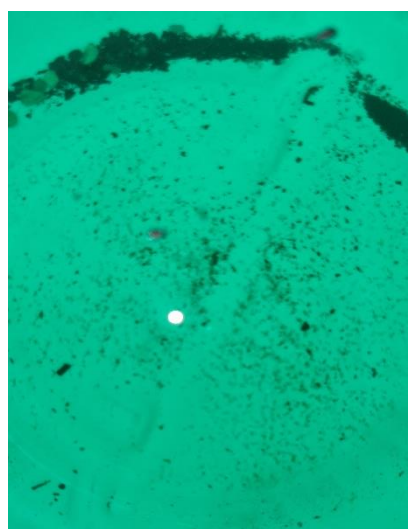
*Figure 65 – Glycol in Sample Container
Noted Sediment*

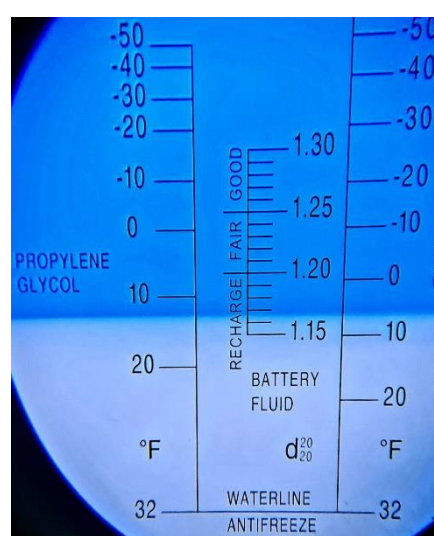
Figure 66 – Glycol Refractometer Results

- The filling of the system with glycol was orderly and there were no unexpected issues except that the second tanker truck was delayed by a day. The amount of glycol was as expected and testing of the solution revealed performance of 12 degrees F.
