Commissioning Report - Ground Heat Exchanger Testing and Observation
Minnesota Veterans Home – Bemidji, MN

October 3, 2023

Commissioning Report - Ground Heat Exchanger and Observations

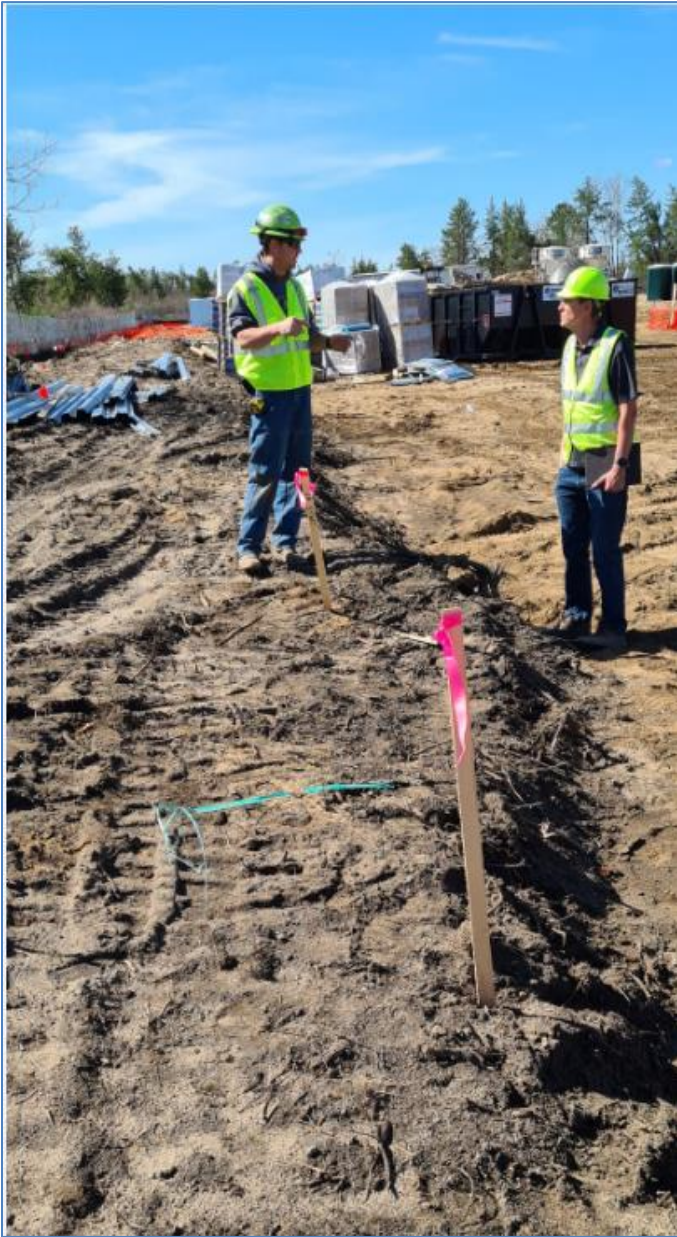
Figure 1: Site facing - North to South for Loopfield Area

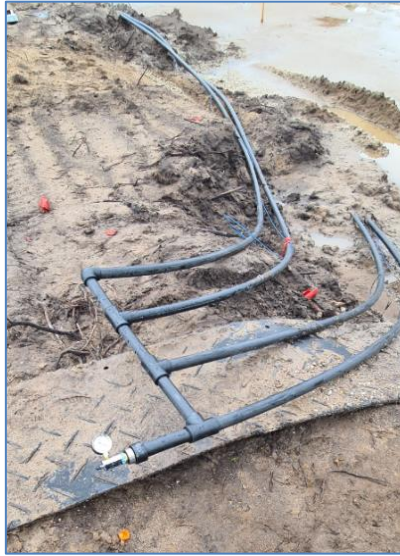
The contractor chose to use air to pressurize the loops, which is not the best or safest way to do the testing and it required a lot of air compressor time to apply enough pressure. They did not have sufficient numbers of pressure gauges available to put separate gauges on each loop, so they were permitted to check multiple loops at a time. At the end of the 24 hours, the pressure observed for detection of any leaks and the air was released. The temporary manifolds were removed and the loops were individually capped. A better method would have been to fill the pipes with water and use the compressor to pressurize only a small amount of air in each pipe.

Figure 15 – Temporary manifold to pressure test more than one loop at a time.

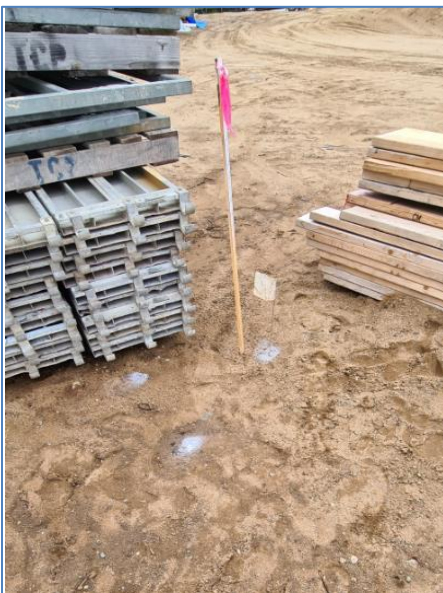
Locating was mostly uneventful and paint markings were used along the entire length of each loop path. A drilling log was retrieved which shows most of the depths of each borehole. We did not receive all of the drilling logs due to the issues with using four different locators until one was found to navigate around the steel culverts. Also, the logs did not include the GPS locations, only the depth of each loop. Some of the boreholes in the vicinity of the building were drilled deeper than the spec to avoid the transformer pad and associated wiring that were located roughly 12-13 feet below the surface. The driller opted to provide extra clearance around the electrical utilities and to maintain separation between the layers of boreholes and the loops.

Figure 17 - Locating. Working around some of the materials being used on-site

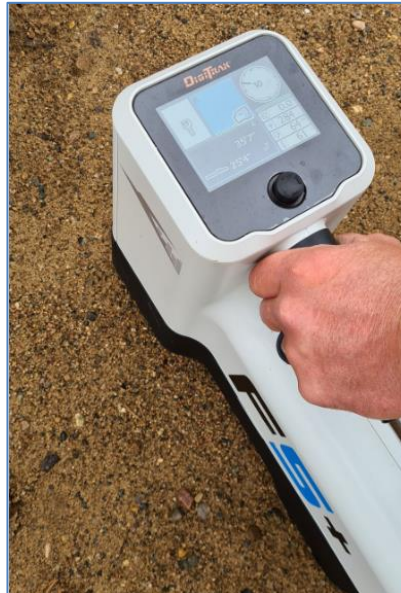
Figure 18 - Locating w/ DigiTrak F5+

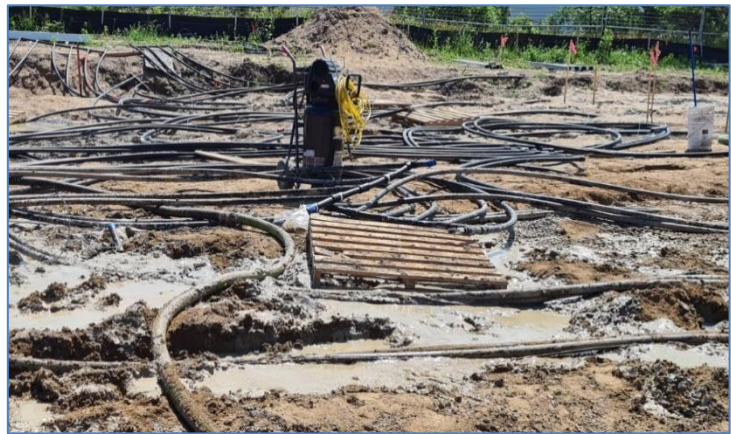
Figure 26 – The tailpieces of numerous installed loops

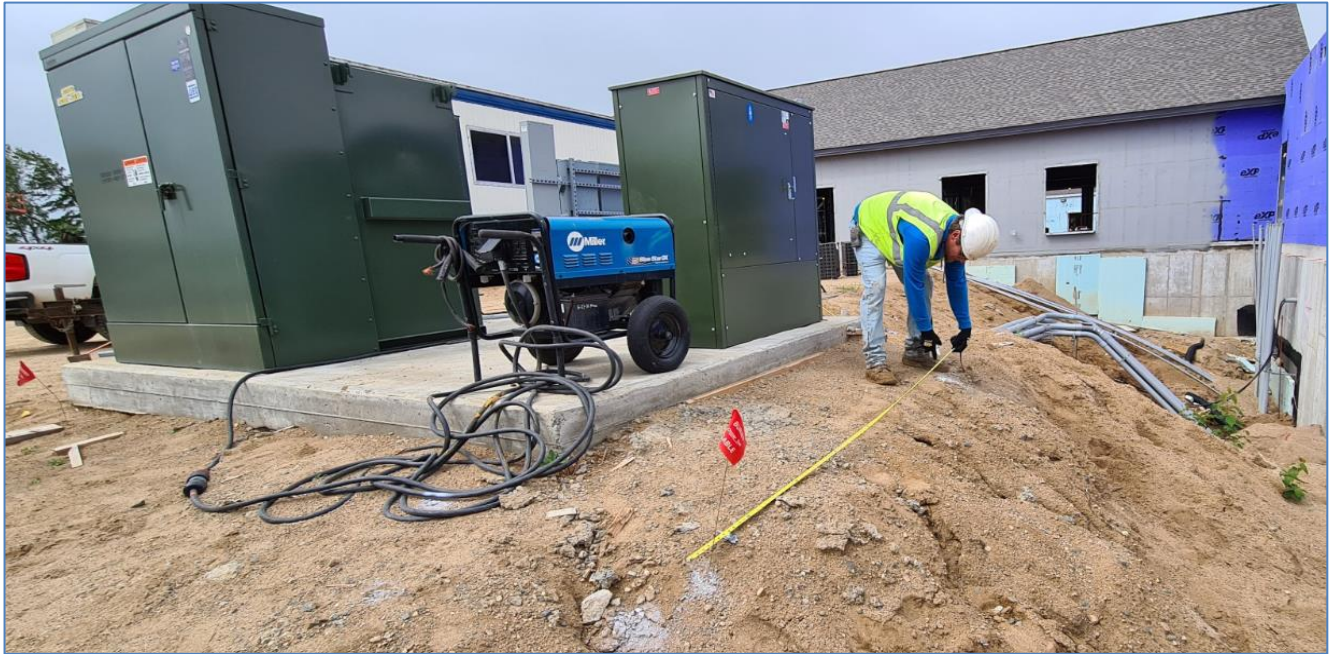
Figure 29 – Checking locations of loops that run beneath the electrical service hookups

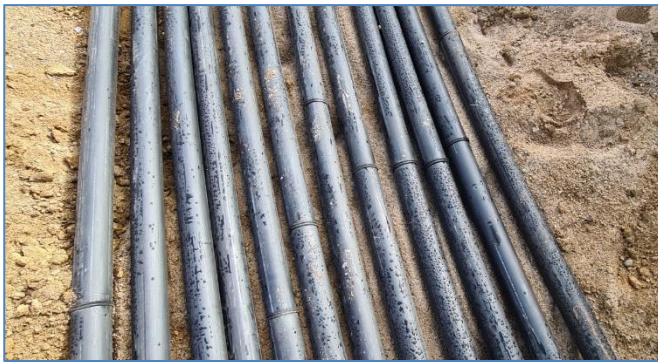
Figure 33 – Supply/Return Lines showing butt fusions

- Fusions were observed for all types of couplings; saddle and butt connections. Destructive samples were taken of butt connections on couplings for 1.25" connections and for 3" butt connections. The samples showed excellent coverage. The fusion rolls were textbook quality.

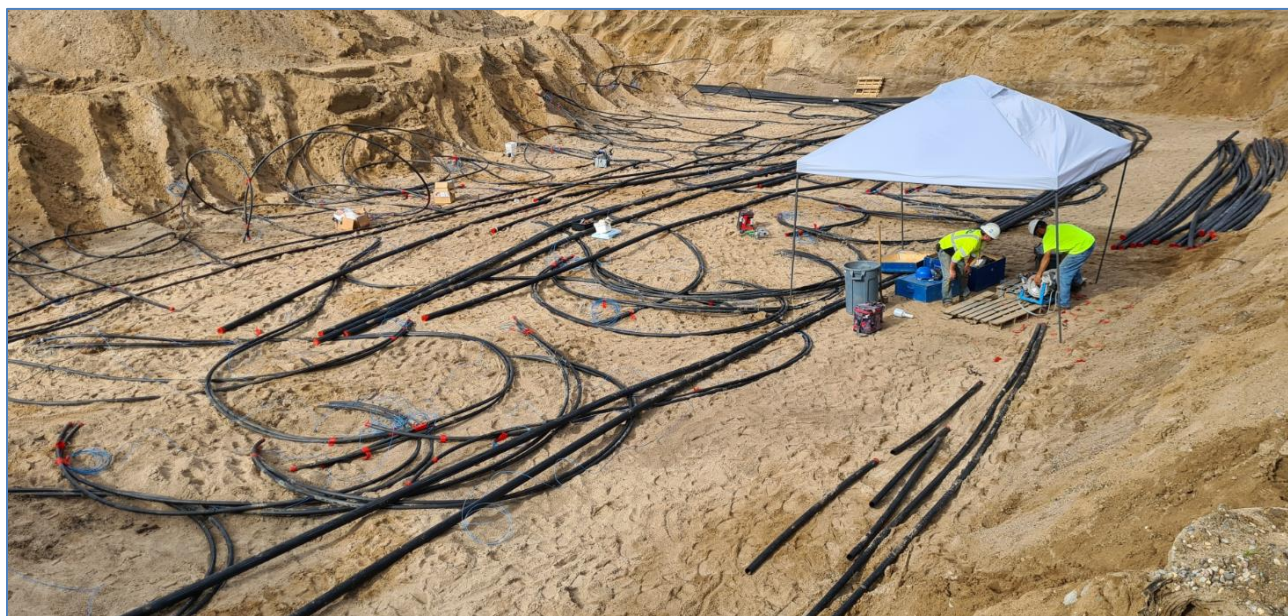
Figure 39 – Area excavated for circuit tie-ins to loopfield and working area for preparation of 3" circuit supply/return lines.

The tie-ins to the loopfield were done 8-9 feet below grade in an area that was fully excavated to allow equipment to drive and compact soils at the end of the process. Noted that there is a hydrant line that runs roughly two feet below where all of the tie-ins are made. Caution will be needed if any hydrant or water main work needs to be done in this area. Yellow caution tape is placed about 4-5 feet below the surface and directly above each running supply/return pipe that extends to connect the GHX loops. All tracer wires tied to their related circuits. The loopfield tie-ins and reducing headers which connect to the 3" circuit pipes were all inspected for proper fusions all crossings of pipe were hand bedded to reduce any stress on the pipes. The material excavated consists primarily of sandy soils with very few small rocks. Crews walked the area and removed any stones larger than a couple inches across. The walls were not very stable as sand did collapse from the sides during the time that the pit was open. Ladders were utilized to climb in and out of the pit. Loopfield pipes exited the bottom of the south wall and came up from the floor of the area excavated. There was good evidence of grout wherever the loops entered the floor or the bottom of the sidewall, which indicates that the boreholes grouting was effective. Supply and return lines connect to the 3" circuits through a series of reducing headers that are configured in reverse-return configuration from 1.25" pipe through 2" and 3" connections. Noted on the East area of

the trench, there is a 16" concrete culvert running N-S which was temporarily removed as it ran above the area where the tie-ins were connected. I did not observe the replacement prior to leaving the site. The piping and connections and tracer wires are all very neatly configured and prepared.

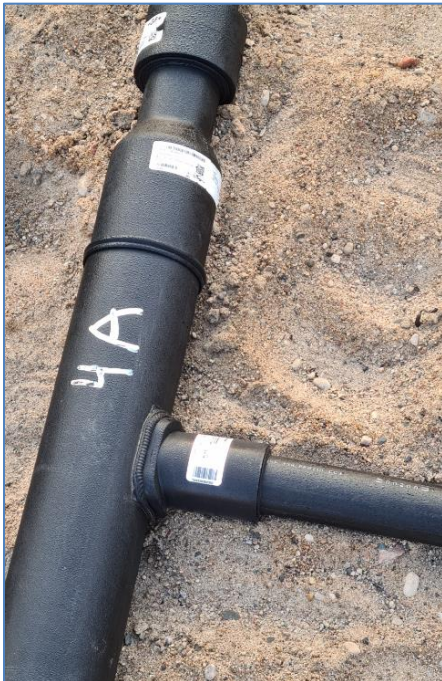
Figure 44 – Typical Saddle Fusion and Circuit Markings

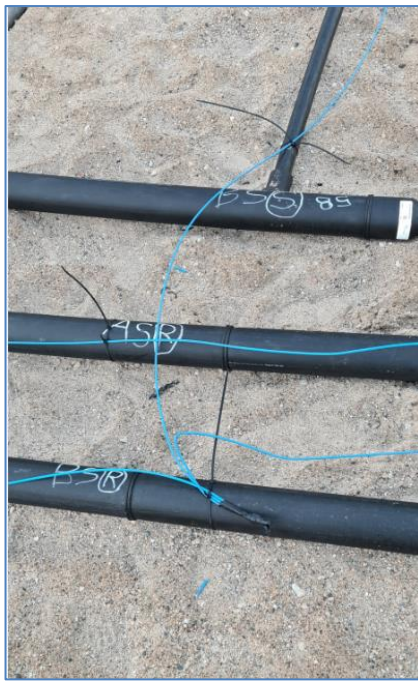
Figure 45 – Supply/Return Circuit Markings and Tracer Wires

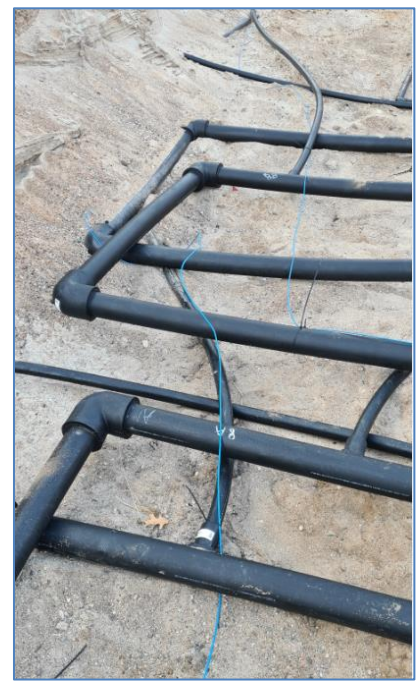
Figure 46 – Circuits at E Wall of Trench where the Connections Reverse

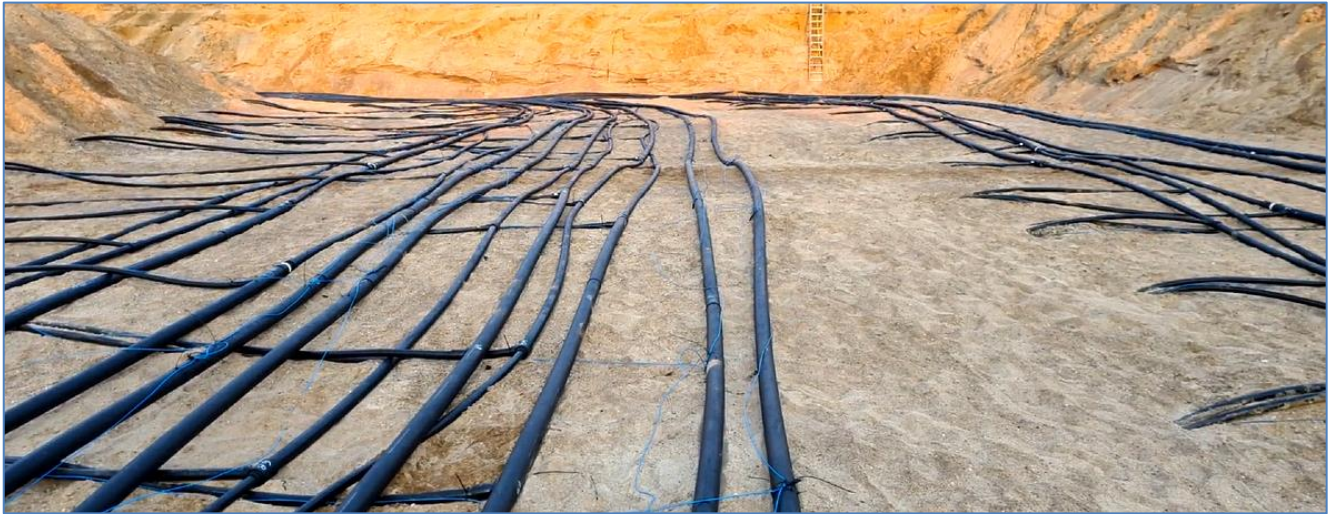
Figure 47 – Circuits and Tie-Ins ready for Pressure Testing

After all connections were completed, each fusion was visually inspected prior to pressurizing the system. Each circuit (x6) and connected loops (x8 loops/circuit) were filled with mains water from the Mechanical room and pressurized to 100PSI for 24 hours prior to backfilling. Temporary plumbing was affixed to each of the supply/return pipes to allow for filling and pressurization.

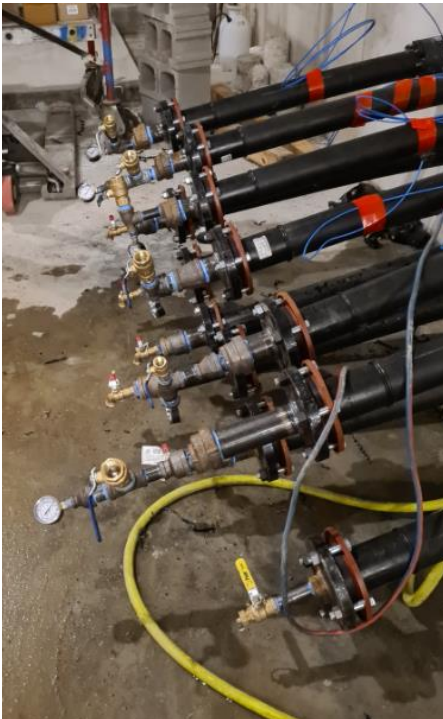
Figure 48 – All Circuit Pipes in Mechanical Room Temporarily Plumbed for Testing

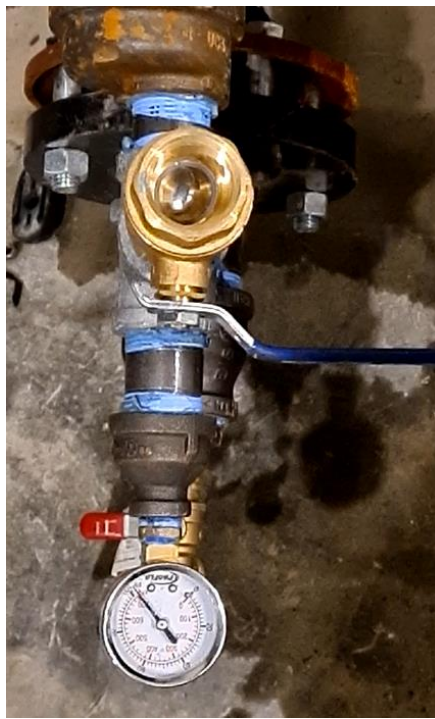
Figure 49 – Each Circuit (x6) Filled with Mains Water and Pressurized to 100PSI

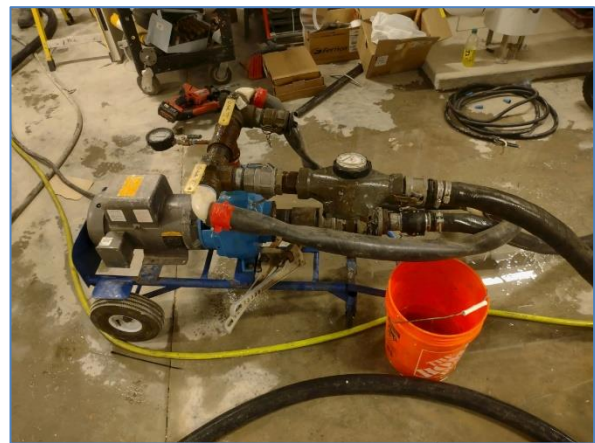
The Geothermal Heat Exchanger System was allowed to sit over the winter and was flushed/purged in August of 2023 by Mineral Services Plus (Danny Knubbe IGSHA #20041-0509. Each of the (6) circuits were flushed individually for 45 minutes in both directions at ~104 GPM and ~48 PSI supply pressure per photo and video. The initial water for system was taken directly from a potable source on site in September of 2022 for pressure testing the GHX piping prior to backfill of the trenches. A portable purge pump, Goulds Water Technology 50SPM20F, was used for the flush/purge operation. The setup included a 5-micron filter bag assembly and an air separation tank. Connections were made through a reversing valve manifold assembly using 3" hose connections.

Figure 55 - Goulds Water Technology 50SPM20F
Purge Pump w/pressure and flow meters.

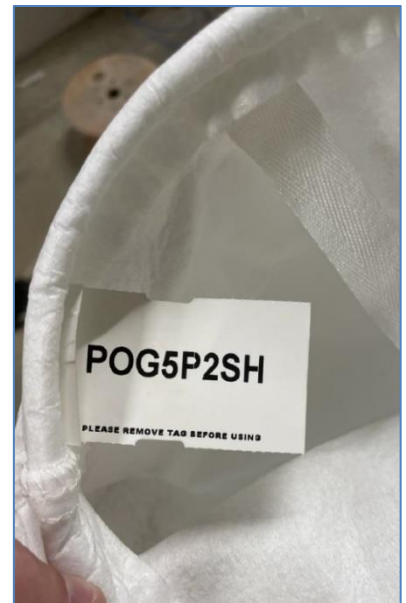
Figure 60 – Polypropylene Felt Bag Filter w/ Carbon Steel Ring – 5 Micron

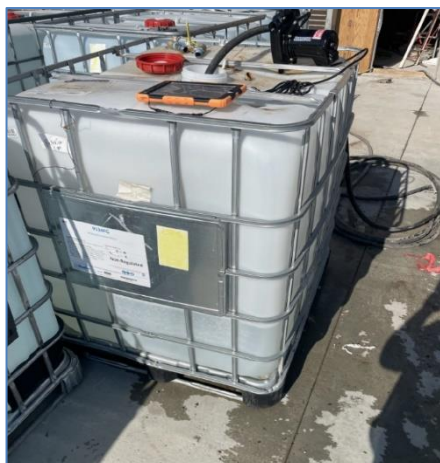
PSM estimates that 1,750 total gallons of concentrate were used and that included an additional 250 gallons of concentrate installed at a later date as the initial needed quantity on-site was short by one tote.

Figure 61 – PSM Photo of Glycol Totes

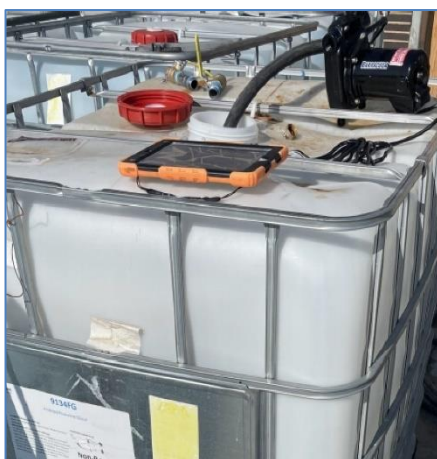
The Glycol Solution was installed beginning August 2, 2023 from glycol concentrate that was “field Mixed” from 250-gallon totes of concentrate, as shown in photos. A small electric transfer pump and 1” hose line were used to introduce the field mixed glycol into a port in the mechanical room per photos.

Figure 62 – PSM Photo – Small Electric Pump Extracting Concentrate from Tote

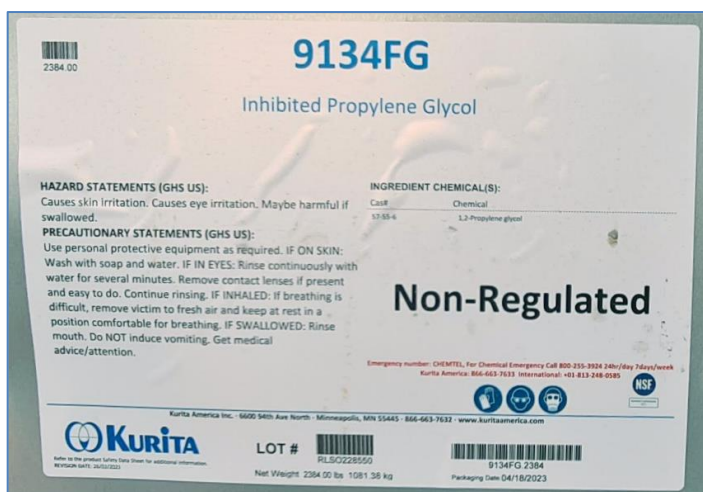
Figure 64 – PSM Photo of Tote Label

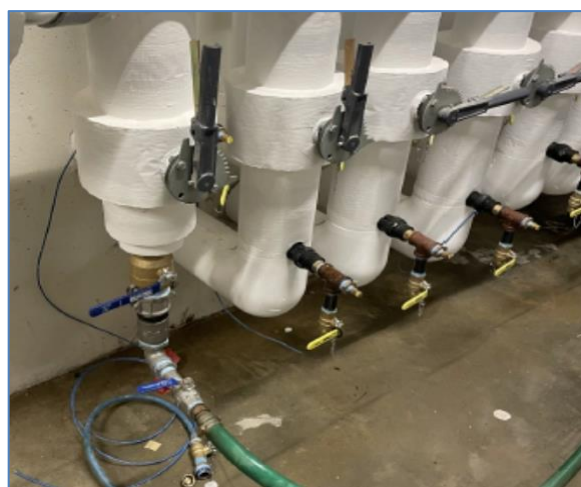
Figure 65 – PSM Photo. From Glycol pump?

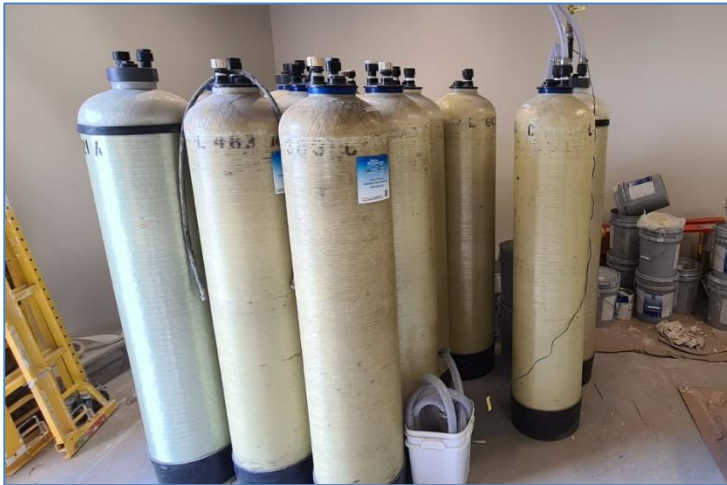
The Glycol Solution which was installed was “Field-Mixed” as opposed to the expected factory 25% premix solution. The field mix was created by means of manually mixing the clear concentrate and local water which was run through a set of filter tanks. The “field mix” was reported to be a ~30% solution by volume and there is no information regarding the mixing process (mechanical paddle mix or simple introduction of glycol to water using the small electric transfer pump). After the field mixed solution was created, the 250-gallon tote was pumped into the system using the small electric transfer pump.

Figure 66 – Filtration Tanks Used to Treat Municipal Water
